# Home Inspection

123 Anystreet St  
Anytown, Anystate 12345

Prepared for: John Homebuyer

Prepared by: Blue Crab Inspections

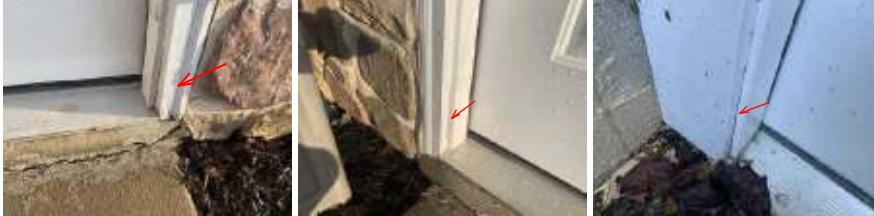
5. Type: Stone, Vinyl siding - Gaps and cracks noted in sealant around home. Recommend filling all gaps and cracks through out exterior of home to prevent moisture penetration. Recommend monitoring all exterior caulking. A qualified contractor is recommended to evaluate and estimate repairs.
6. Trim: Wood, Vinyl - Soft wood present. Gaps and cracks noted. Recommend filling all gaps and cracks through out exterior of home to prevent moisture penetration. Recommend monitoring all exterior caulking. A qualified contractor is recommended to evaluate and estimate repairs.

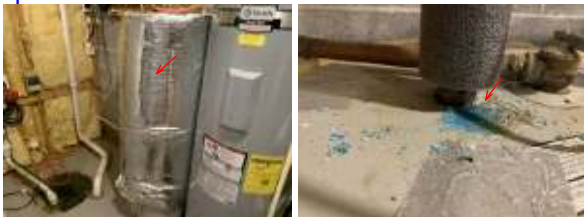
10. Basement Water Heater Water Heater Operation: Functional - Cannot determine the age of water heater due to wrap. Corrosion noted on water heater. A licensed plumber is recommended to evaluate and estimate repairs.

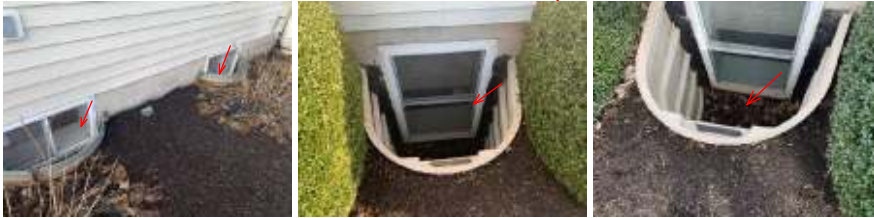
1. Window Wells: Not covered - Uncovered egress windows present a fall hazard. Open window well present, recommend covering to prevent the build up of debris and moisture penetration. A qualified contractor is recommended to evaluate and estimate repairs.

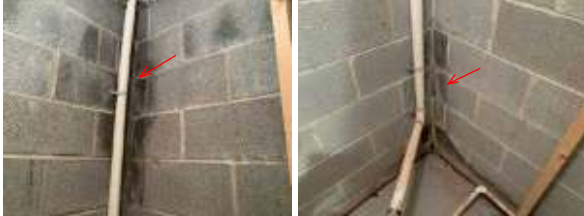
5. Main Basement Moisture Penetration: Present - Water stain(s) noted, verified dry at time of inspection, recommend further investigation into whether the source of the moisture penetration has been corrected. A qualified contractor is recommended to evaluate and estimate repairs.

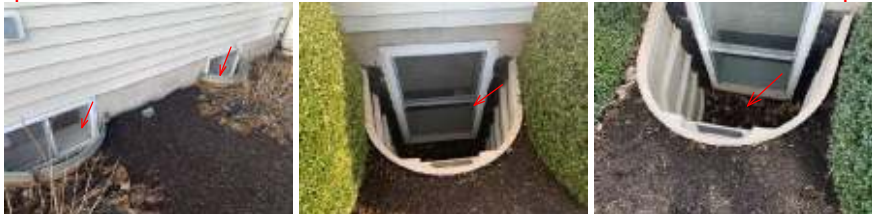
10.  Window Wells: Not covered - **Uncovered egress windows present a fall hazard. Open window well present, recommend covering to prevent the build up of debris and moisture penetration. A qualified contractor is recommended to evaluate and estimate repairs.**

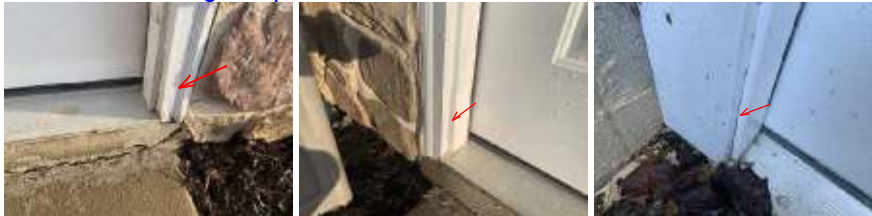
2.  Trim: Wood, Vinyl - Soft wood present. Gaps and cracks noted. Recommend filling all gaps and cracks through out exterior of home to prevent moisture penetration. Recommend monitoring all exterior caulking. A qualified contractor is recommended to evaluate and estimate repairs.

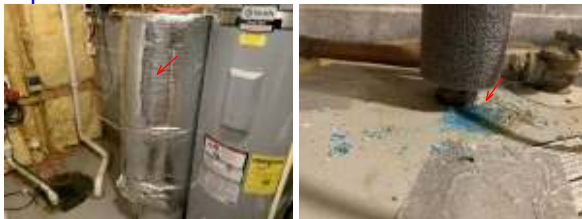
Basement Water Heater \_\_\_\_\_

- 16.  Water Heater Operation: Functional - **Cannot determine the age of water heater due to wrap. Corrosion noted on water heater. A licensed plumber is recommended to evaluate and estimate repairs.**

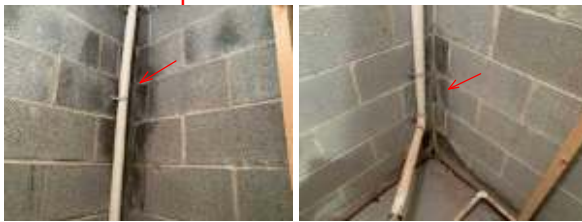
- 13.  Moisture Penetration: Present - **Water stain(s) noted, verified dry at time of inspection, recommend further investigation into whether the source of the moisture penetration has been corrected. A qualified contractor is recommended to evaluate and estimate repairs.**
